AWARENESS BRIEFING

Risk of Structural Failure to Brick Farm Access Bridges

The intention of this briefing note is to raise awareness amongst bridge users of how this type of damage occurs and how it can be prevented in future, and this ensuring your safe use.

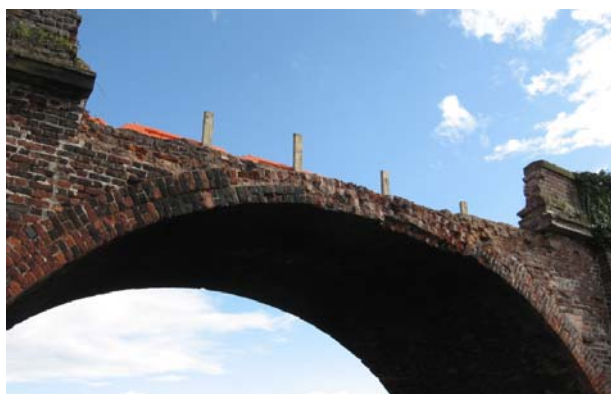
Figure 1 – Damage to farm access bridge at Chester

On un-paved rutted surfaces where large off road tyres on machinery such as telehandlers, can force the side of the ruts outwards (Figure 6), the same detrimental effects described above can occur and were a contributory factor to the failure shown in Figure 1.

- Changes in vehicle width; please be vigilant if vehicles are passing very close to parapets. The damage to the structure shown in Figure 1 was caused by a new tractor the farmer purchased, which although could still pass between the parapets, was wider heavier. Excessively wide vehicles where there is only a matter of inches clearance between both parapets should not be taken over.
- Change in vehicle weights – the damage to Figure 2 was caused by a milk tanker that changed its collection sequence. It previously used the bridge at the start of its collection round when it was empty but subsequently changed to the last pick-up of the day when it was full. The increased weight caused the damage.
- Changes of tyre type; large balloon tyres passing close to parapets may also overload the parapet walls.

The reasons why the failures described occur are simple and damage can be prevented by careful driving and positioning of vehicles so that the wheels are not too close to the parapets.

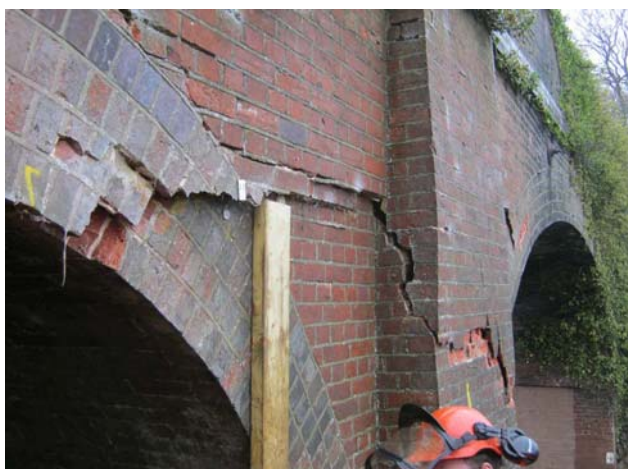
Figure 2 – Damage to farm access bridge in Kent

In Figure 5, depressions and cracking can be seen in the road surfacing where the soil beneath has been compressed by heavy wheel loads. The proximity of the increased loads to the parapet wall led to the damage shown in Figure 2.

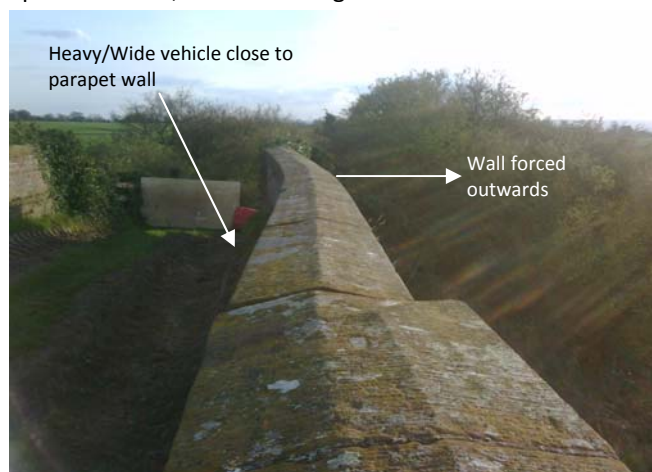
Brick farm access bridges over the railway can be severely damaged by regularly being crossed by heavy and/or wide vehicles. The most common problem associated with heavy and wide vehicles is the damage that can be caused to parapets and the brickwork below the parapets, the 'spandrel' walls, as shown in figures 3 and 4.

Figure 3 – Typical movement to parapet

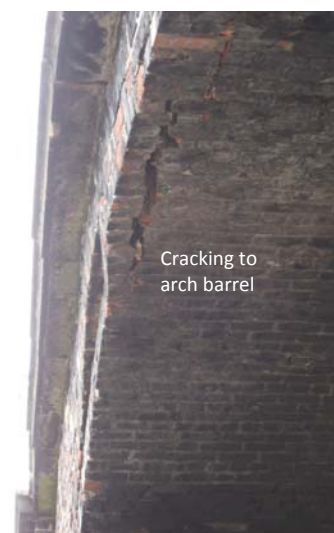
As the parapet is forced outwards it commonly results in severe cracking around the arch barrel as can be seen in the photograph on the right and in the diagram below.

Figure 4 – Cracking around the arch

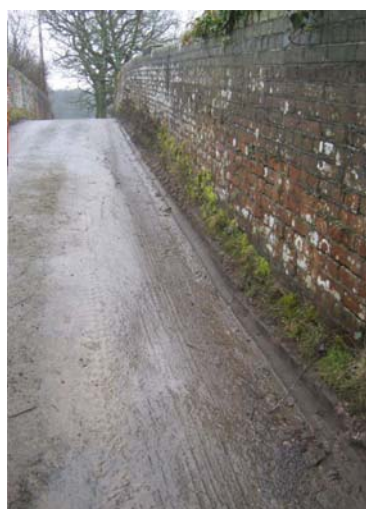
Figure 5 – Cracking and depressions to road surfacing

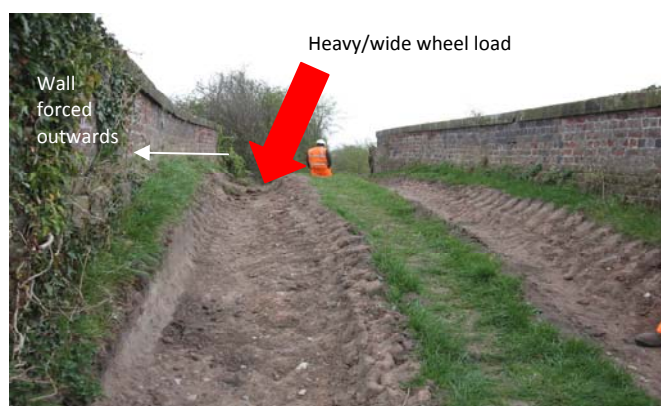
Figure 6 – Typical wheel ruts forcing parapet wall outwards
